## HIGH-RESOLUTION NITRATE & NITRITE MONITORING IN A WEST CORK RIVER BASIN

*Rosscarberry, West Cork*

In October 2021, Ireland's Local Authority Water Programme (LAWPRO) for the South-West Region was using a mains-powered Aquamonitrix® analyser to quantify the nitrate load entering an estuary in Rosscarberry, West Cork, so the location was ideal to trial the performance of a battery/solar-powered pack we developed to power a second 'unplugged' Aquamonitrix® unit.

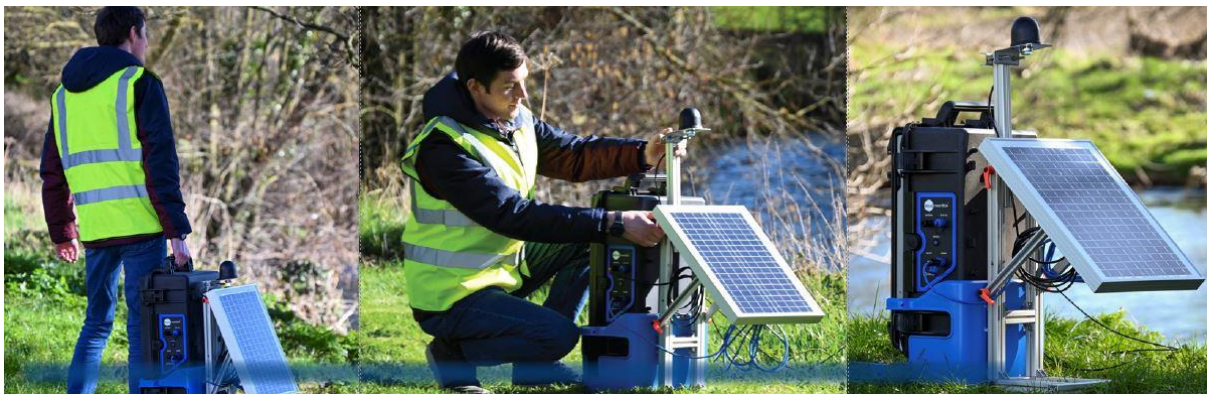
In this dual deployment, the battery/solar powered Aquamonitrix® unit was deployed upstream from the mains-powered Aquamonitrix® analyser.

*Aquamonitrix® mobile unit powered by a solar/battery pack*

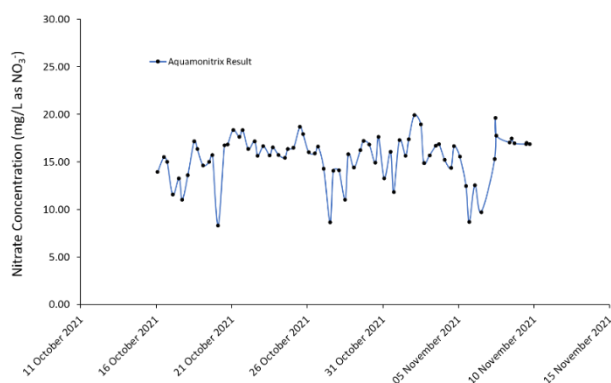
Over the one-month deployment, both analysers provided identical nitrate measurements, ranging from >10 to >20 mg/L nitrate (as  $\text{NO}_3^-$ ) as shown in Figure 1 below.

Figure 1: Nitrate level measured over as one-month period as mg/L  $\text{NO}_3^-$ .

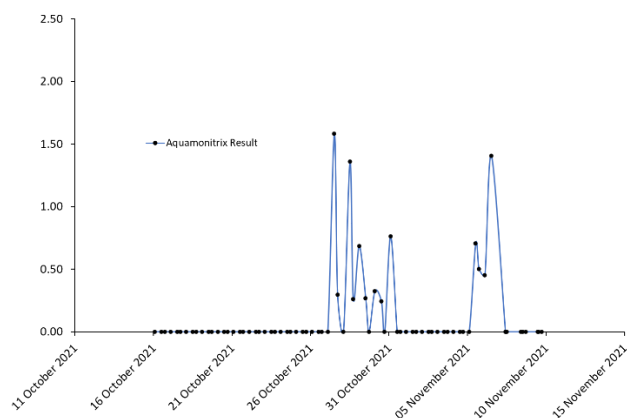
However, the second unit, being deployed as the mobile analyser also picked up elevated nitrite concentrations of 1.58 mg/L (as  $\text{NO}_2^-$ ), as illustrated in figure 2 below.

Figure 2: Nitrites level (as mg/L  $\text{NO}_2^-$ ) measured by the battery/solar powered mobile Aquamonitrix® unit

An assessment of the area revealed the source of the nitrite was a leaking storage tank on a farm approximately 1 km upstream, and this was confirmed with grab samples.

“Finding didn’t patricianly surprise me,” commented Dr Paul O’Callaghan, a Catchment Scientist with LAWPRO South West. “When you have ammonia and nitrate, you can expect that nitrite will also be in there somewhere. By the time the flow was reaching our fixed-position analyser at the mouth of the river, the nitrite had already oxidised to nitrate. But our mobile monitoring revealed that the nitrite pulse persisted for about 1 km downstream. That would indicate nitrite is less transient than some models indicate.”
